Webster-Highland Lakes Watershed Partnership

Prepared for **City of Franklin,
Municipal Services Department
43 West Bow Street
City of Franklin, NH 03255**

Prepared by **Vanasse Hangen Brustlin, Inc.
Six Bedford Farms Drive
Suite 607
Bedford, NH 03110-6532**

**November 2, 2006
DRAFT - Final**

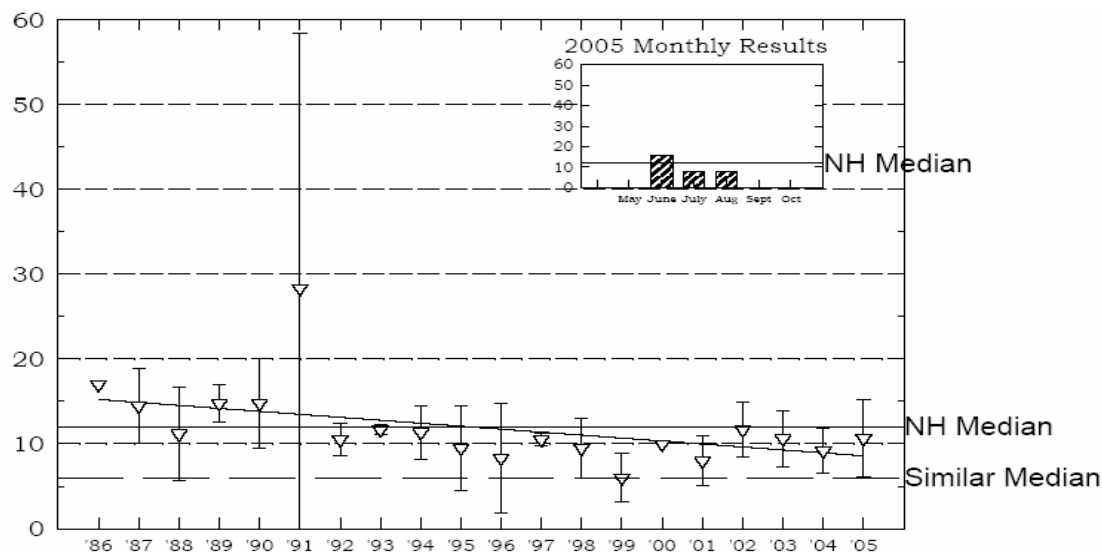
Figure 3.1-1
Historical Total Phosphorus Concentrations (ug/l) in the Epilimnion of Webster Lake

Figure 3-1 presents the maximum, minimum and average total phosphorus concentrations observed for each summer season in the epilimnion (upper water layer) of Webster Lake since 1986. Since 1992, the summer epilimnetic total phosphorus concentrations have averaged between 6 and 12 parts per billion (ppb). The maximum concentration during that time period was no greater than 15 ppb. Prior to 1992, the average concentrations were generally higher and closer to 15 ppb or slightly higher in one year. The maximum concentrations during the pre-1992 period were generally in the 18-20 ppb range and in one year, 1991, the maximum concentration was 59 ppb. This high level is an anomaly and was likely either due to a contaminated or unrepresentative sample or a reporting error. The trend line in Figure 3.1-1 indicates a declining trend in epilimnetic total phosphorus levels which suggests that nutrient loading may also be gradually declining. The 2005 Annual VLAP Report has reported that this declining trend is statistically significant. The historical average concentration is estimated to be 11.9 ppb based on the mean of the seasonal average concentrations for all 20 years and this would be very close to the median epilimnetic concentration of 12 ppb for all NH lakes in the VLAP system. However, in lakes with similar volumes and mean depth, the median epilimnetic phosphorus concentration is estimated to be 6.0 ppb which is significantly lower than that calculated for Webster Lake. Based on DES

guidelines for lake trophic status classification, the seasonal average phosphorus concentrations would place Webster Lake in the low to mid “mesotrophic” category.

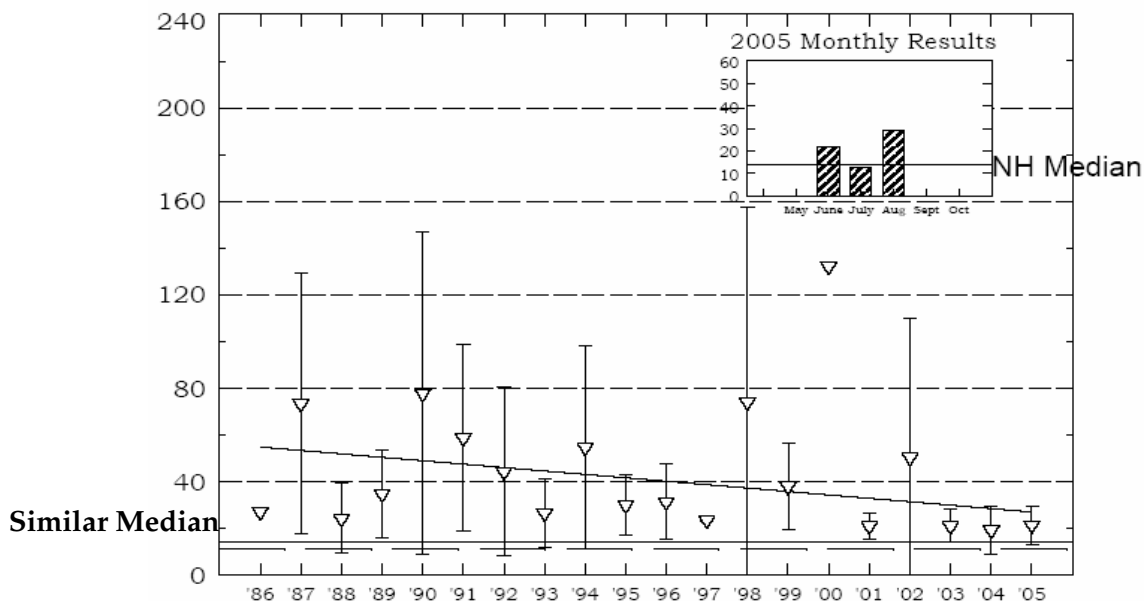
Figure 3-2
Historical Total Phosphorus Concentrations (ug/l) in the of
Hypolimnion of Webster Lake

The historical total phosphorus levels in the hypolimnion (deep water layer) have generally been much higher and consistently above the median level observed in other NH Lakes for the entire period of record. Average concentrations (taken at mid-depth of the hypolimnion) ranged from low of around 20 ppb in 2001, 2003, 2004 and 2005 to highs of 80 and 130 ppb in 1990 and 2000, respectively. Maximum concentrations have exceeded 100 ppb in 7 out of the 20 years in the database. The higher phosphorus levels in the hypolimnion are due in large part to the anoxic conditions that are prevalent at depth. Phosphorus tends to be released from bottom sediments and organic matter in low oxygen environments. As stated earlier, as algae dies and sinks to the bottom, the decomposition of this material consumes oxygen and can contribute to anoxic conditions. Organic loading from other sources such as decaying aquatic plants tributary sources may also create an oxygen demand in deeper lake waters.

Similar to the epilimnetic phosphorus concentrations, the data show that phosphorus concentrations in the hypolimnion were considerably higher in the late 1980's and early 90's. Importantly, phosphorus levels in both the epilimnion and the hypolimnion show statistically significant declining trends. Interestingly enough, the phosphorus concentrations in both the epilimnion and hypolimnion were relatively low from a historical perspective in the summers of 2003 and 2004 when the nuisance algal blooms were observed. This may suggest that other factors or very localized conditions may have contributed to the algal blooms in Webster Lake that may not be entirely reflected in the available phosphorus data measured in the middle of the Lake.

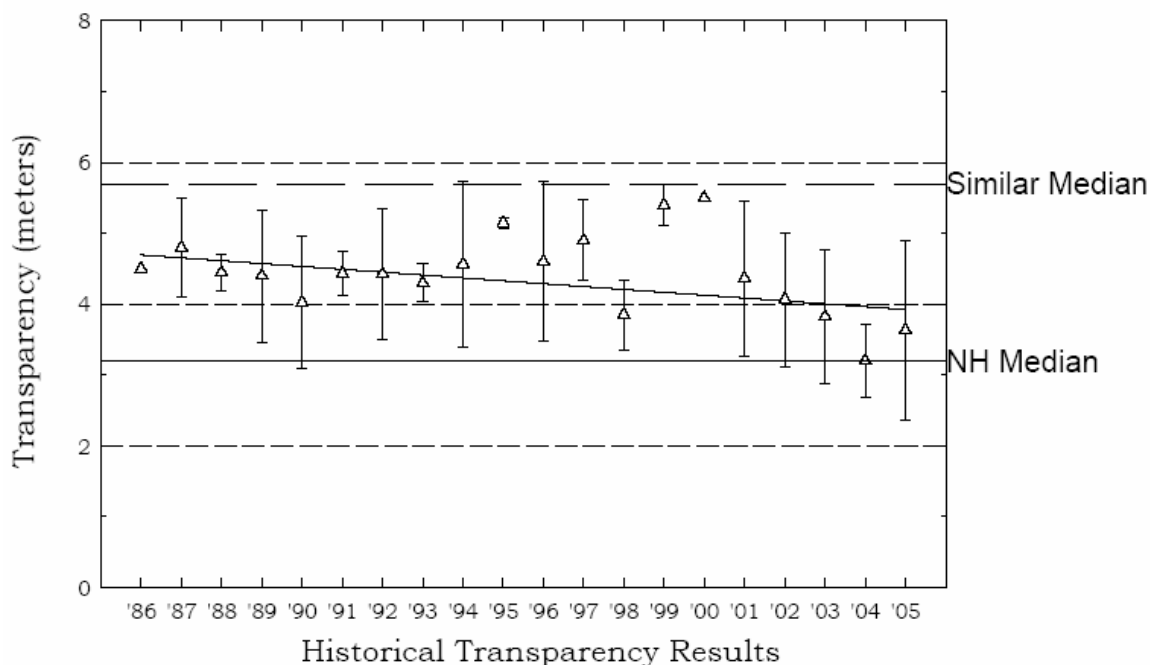
Figure 3-4
Historical Average Secchi Depth Readings in Meters
(Water Transparency) for Webster Lake

The historic summer Secchi disk readings have generally averaged around 4 to 5.5 meters (13 to 18 feet). According to the DES guidelines, these values are in the “good” to “exceptional” category, and considerably better than the NH Lake median value of 3.3 meters. However, lakes with similar mean depth and volume appear to have better transparency with a median Secchi depth reading of 5.8 meters. The 2005 Annual VLAP Report indicates that there is a statistically significant, declining trend in Secchi depth readings. This is especially true in the last 4 or 5 years which is not consistent with either the total phosphorus or chlorophyll *a* data. The worst year for transparency appears to be in 2004, with an average Secchi depth reading of 10 feet or 3.3 meters, which is the lowest in the 20 year history. This low transparency could be partially explained by chlorophyll *a* values for 2004, but total phosphorus data do not support either elevated levels of chlorophyll *a* or reduced Secchi depth. Conditions in 2005 appear to be slightly worse in terms of total phosphorus than in 2003 and yet there were no noticeable blooms of cyanobacteria in 2005. It is difficult to explain why cyanobacteria became so abundant in 2003 and 2004 but not in 2005. It is also unclear as to why transparency has diminished in recent years despite the improving or declining trend in phosphorus concentrations. If the reduction in transparency is due to increased turbidity from sediment erosion and related soil disturbances or storm events, then the summer of 2006 should have particularly poor transparency conditions given several extreme storm events that occurred in May and June.

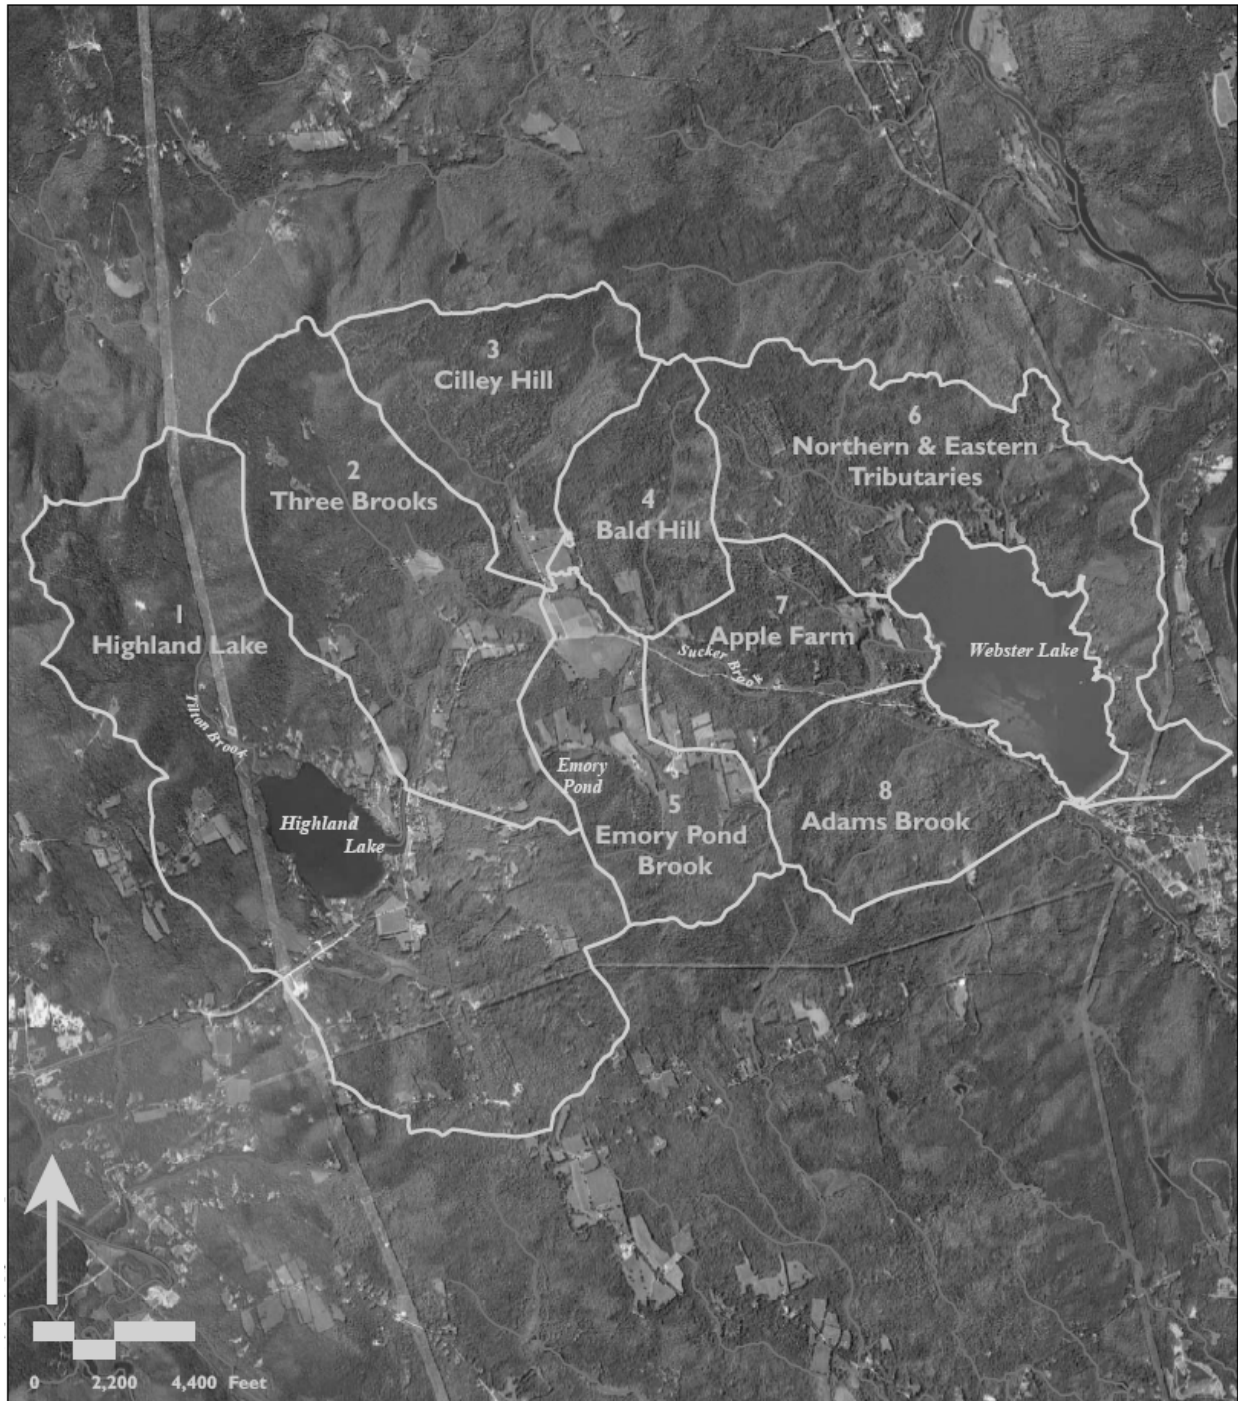
Figure 4-1
Webster Lake
Sub-Watersheds

Legend
 ~ Stream (USGS)
 Webster Lake Sub-Watersheds

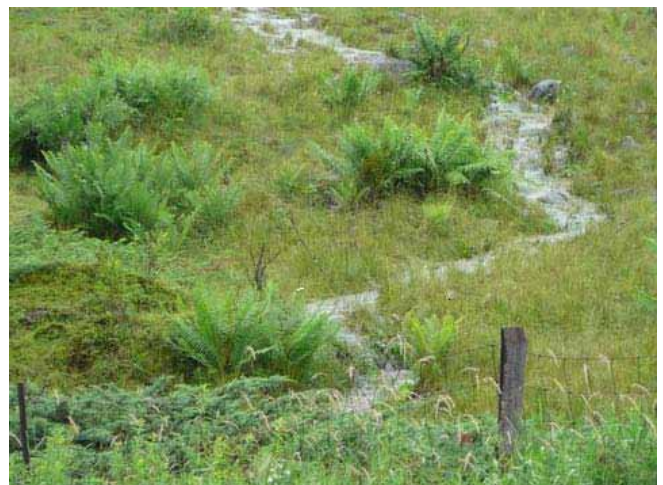
The Hersey Farm also utilizes pasture area on the north side of Route 11, along side of Sam Hill Road as the land slopes down to Sucker Brook. The pasture area sits on a moderate slope with till soils that have limited infiltration capacity. There is fence along the lower base of the pasture area that abuts the abandoned railroad bed that is about 75 to 100 feet from Sucker Brook. However, higher up in the pasture area, runoff flows through numerous drainage ditches that flow toward and eventually into Sucker Brook (see adjacent photo). These drainage ways are traversed by the cows and potentially convey nutrients

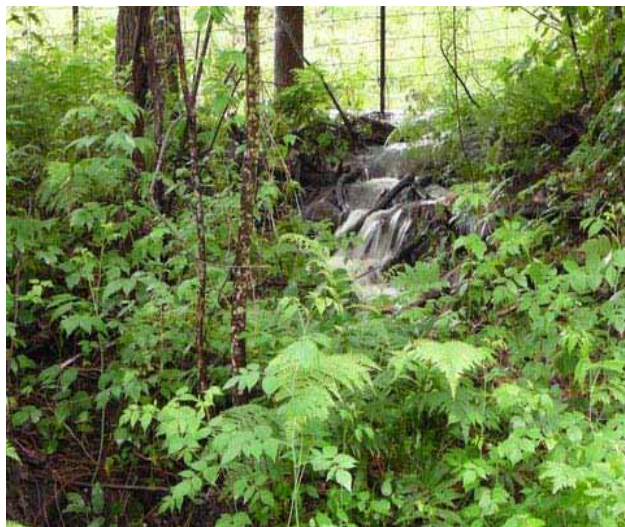
during major runoff events. The flow from these ditches drains across the railroad bed and into a channel that leads to Sucker Brook (see photo below).

Therefore, even though there is a substantial natural buffer between the pasture area and Sucker Brook, there is still channelized flow from the fields through this buffer into Sucker Brook. Some of this flow originates from Sam Hill Road and is diverted into the fields to minimize the erosive forces that are scouring the roadside ditches. This is generally a good drainage practice as long as nutrients from manure deposits are not also be conveyed to Sucker Brook by these ditches. To divert back into the roadside ditches would require substantial

reinforcement with rip-rap stone and widening of the roadside ditches to handle the increased flow. This could be a relatively costly effort perhaps costing as much in \$15,000 to \$20,000, much of it in rip-rap material. Adding more drainage area and flow to these road side swales is not recommended.
